MDOT RC-1514

# **Combining Link Slab, Deck Sliding over Backwall, and Revising Bearings**

**FINAL REPORT – AUGUST 2008  
(APPENDICES)**

# **COMBINING LINK SLAB, DECK SLIDING OVER BACKWALL, AND REVISING BEARINGS (Appendices)**

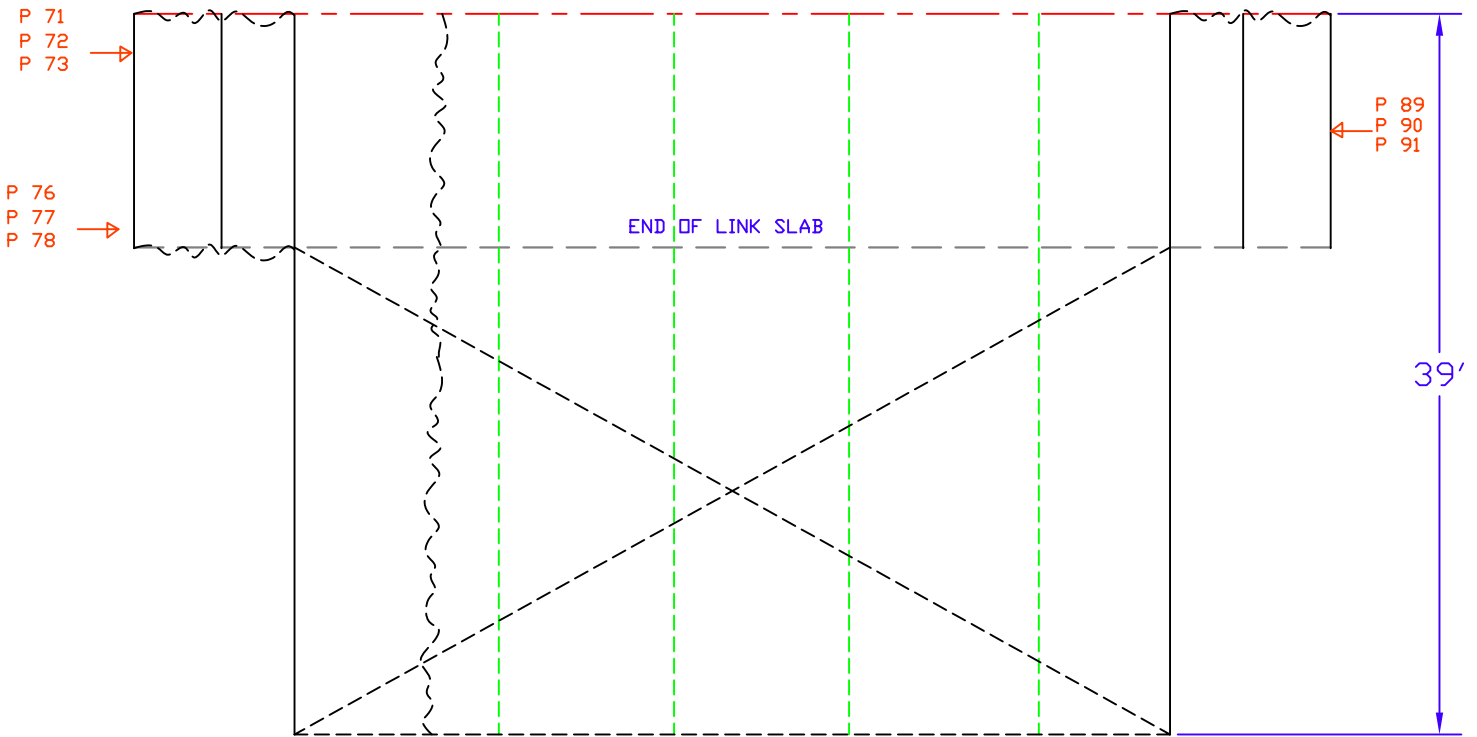
BRIDGE DECK  
 SOUTH SPAN 3

\*\*CANNOT SEE IF CRACKS GO  
 ALL THE WAY THROUGH  
 SINCE IT IS STAY-IN-PLACE FORM

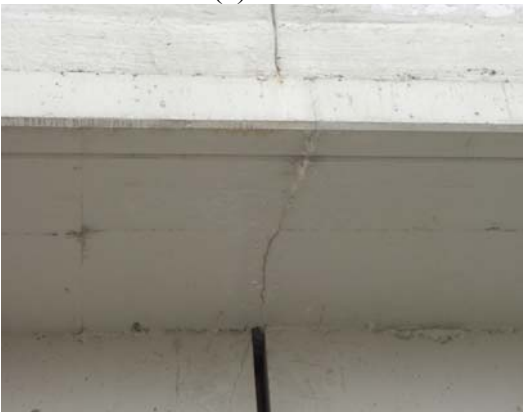
(a) Saw cut on the link slab above the pier centerline

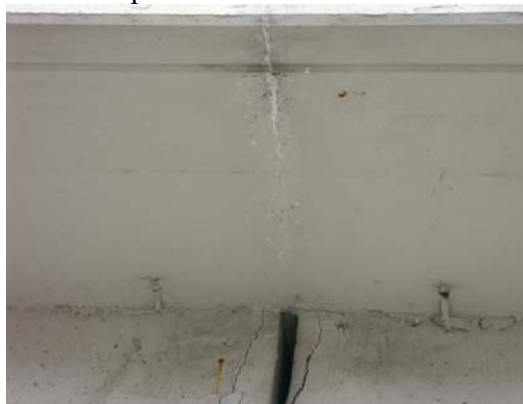
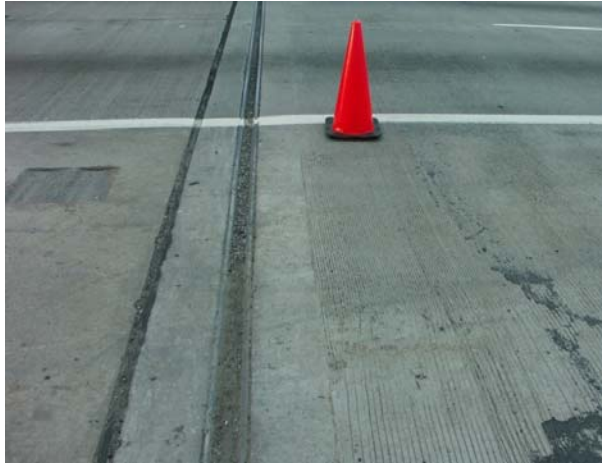
**Photo C - 2. Link slab condition**

(b) Full depth link slab cracks – deck overhang  
North Bound

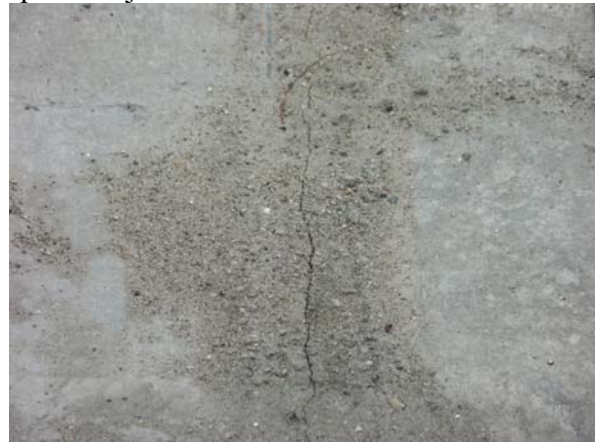
**Photo C - 3. Expansion joint condition**

(b) Cracks on debris filled expansion joint

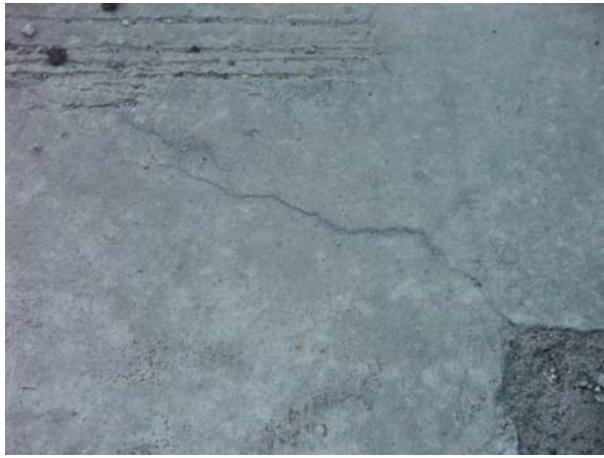
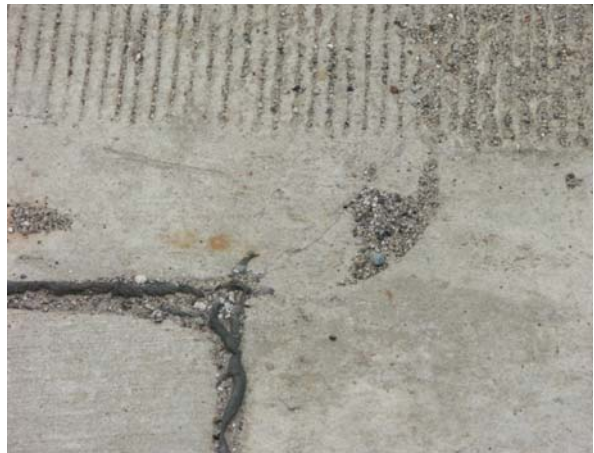
**Photo C - 4. Diagonal cracking at the bridge deck corner**

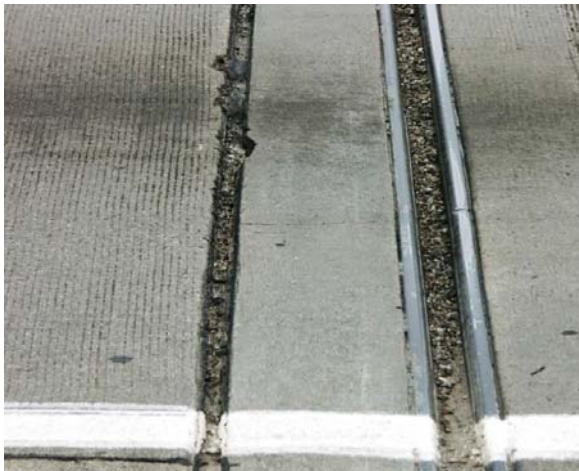
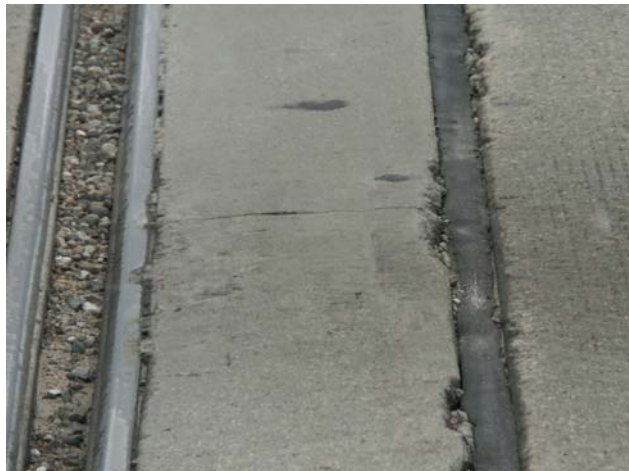
**Photo C - 5. Sleeper slab condition (I-75 south bound)**

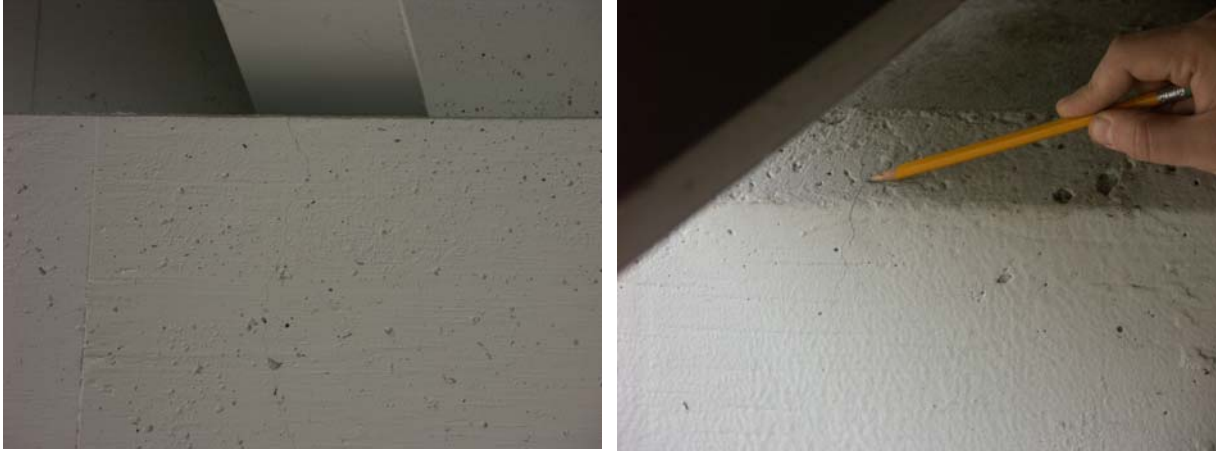
**Photo C - 10. Abutment wall cracking**

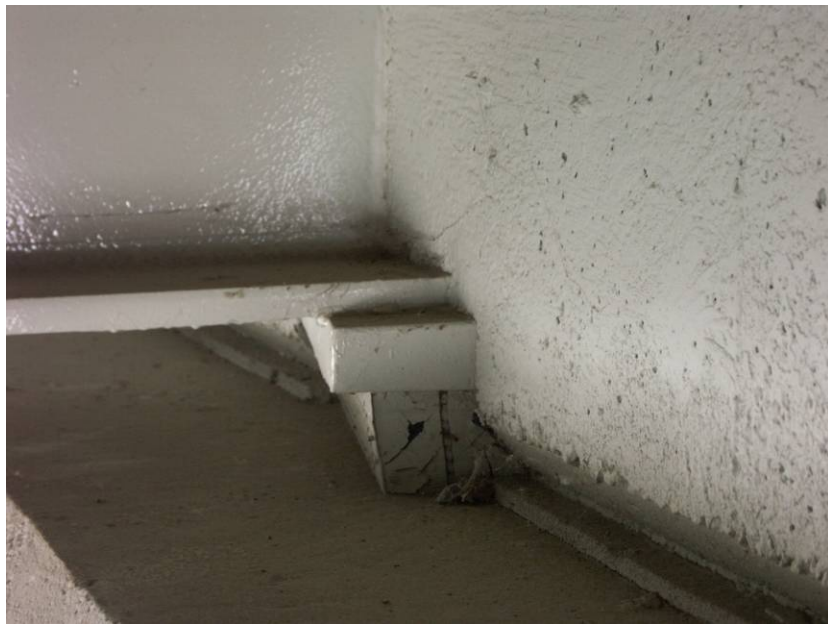
**Photo C - 11. Deformed bearing**

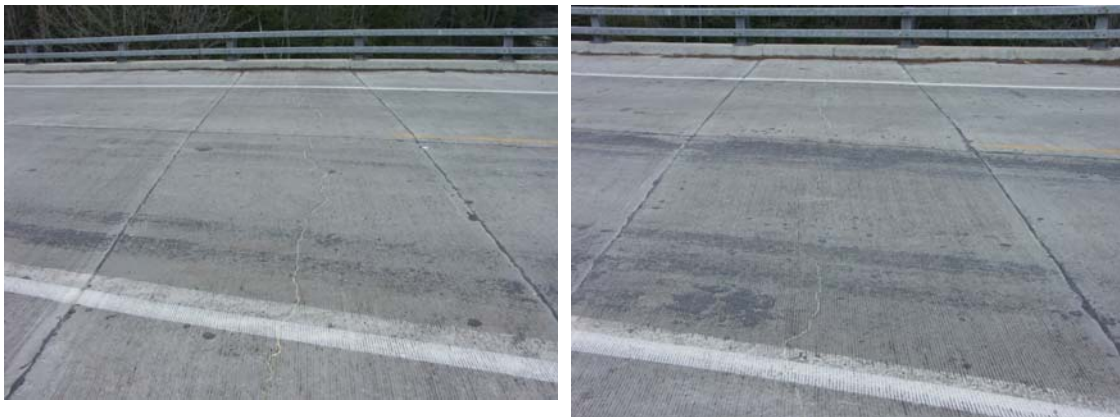
**Photo C - 13. Link slab cracking**

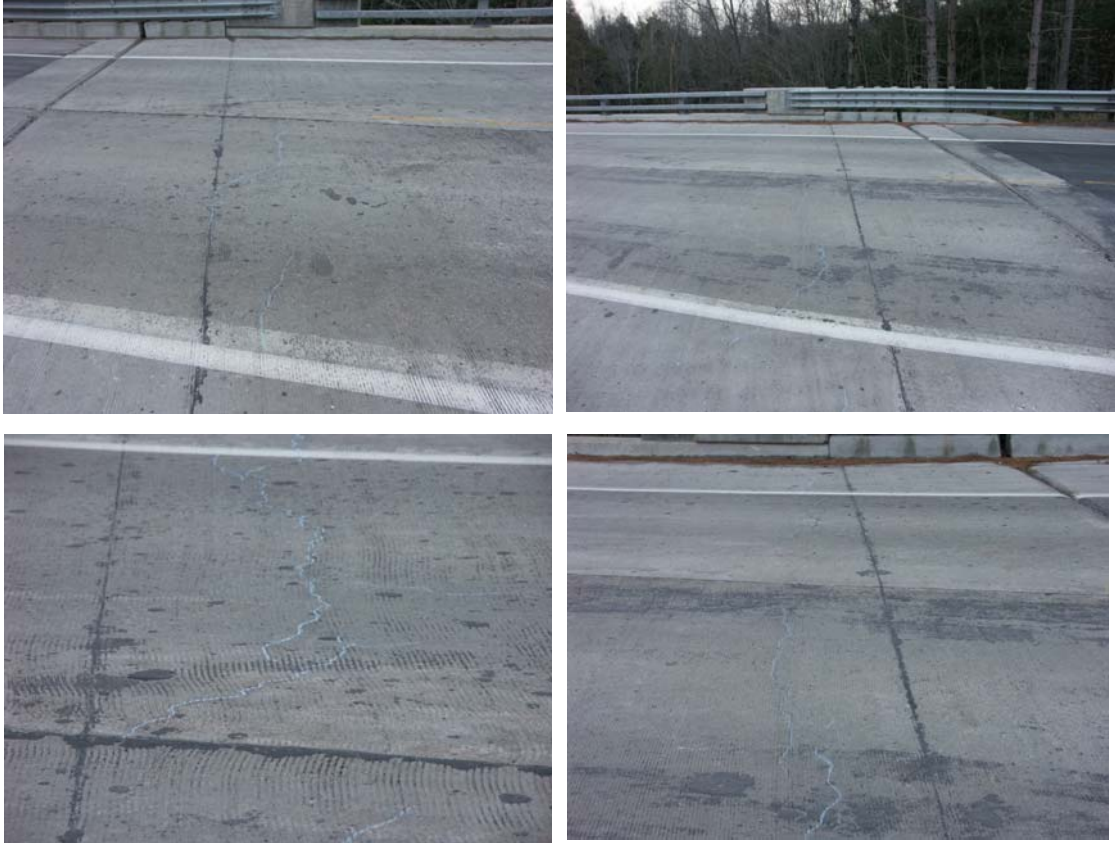
**Photo C - 14. Approach slab cracking**

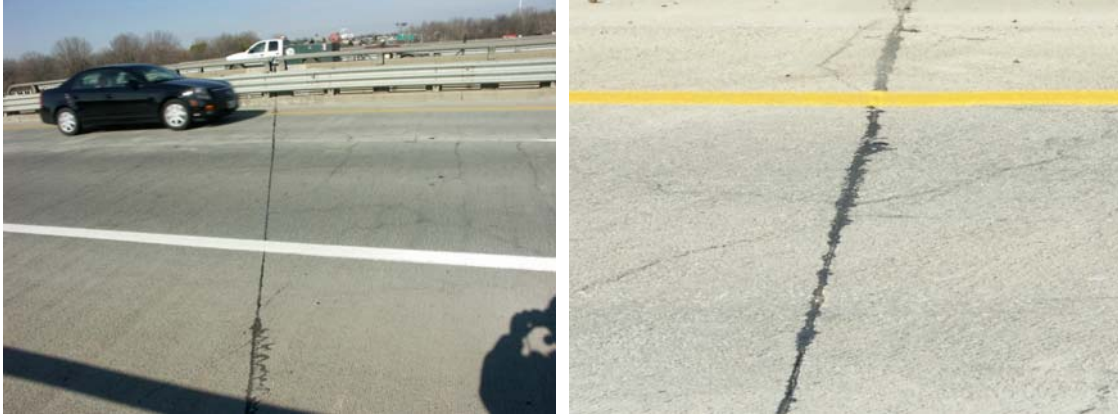
**Photo C - 19. Saw cut provided on the link slab over the pier (I-69 EB)**

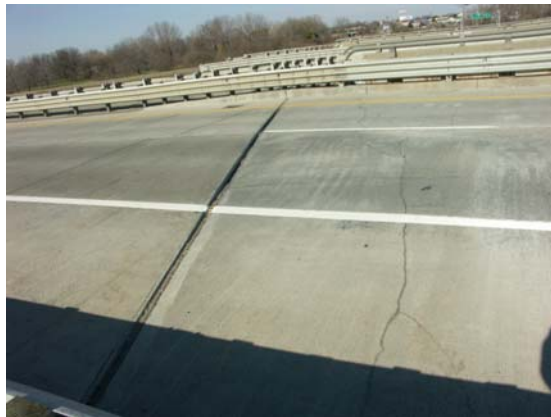
**Photo C - 20. Approach slab cracking over the abutment (I-69 EB)**

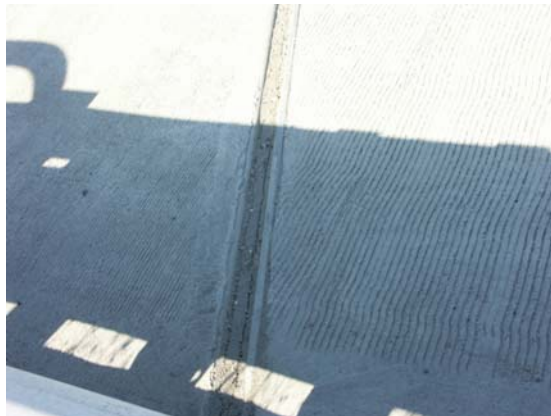
**Photo C - 21. Debris filled joint with cracks (I-69 EB)**

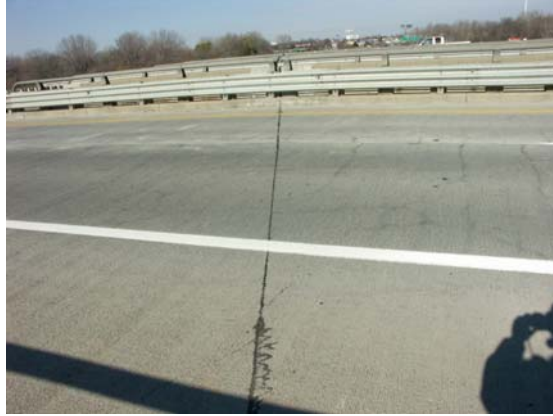
**Photo C - 22. Transverse and diagonal cracks on I-69 EB bridge deck**

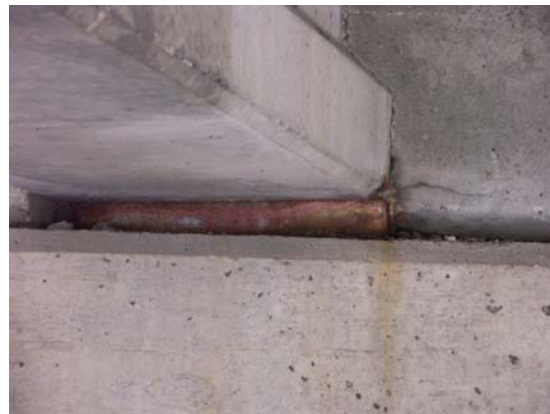
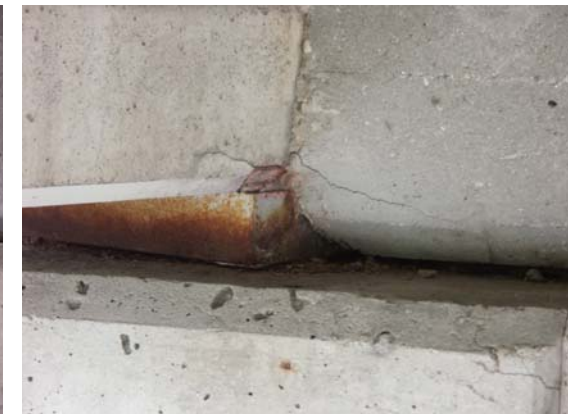
**Photo C - 29. Backwall cracking at the vicinity of bearings**

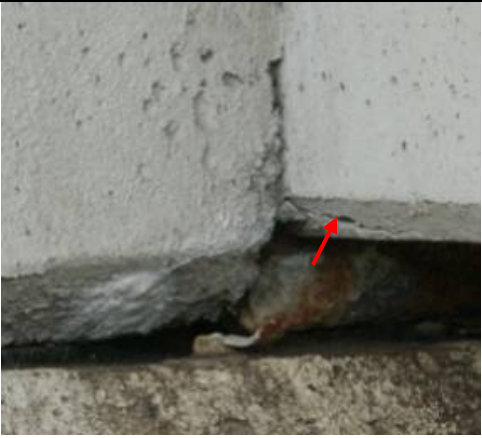
<p data-bbox="414 730 636 758">Crack in beam 1W</p>

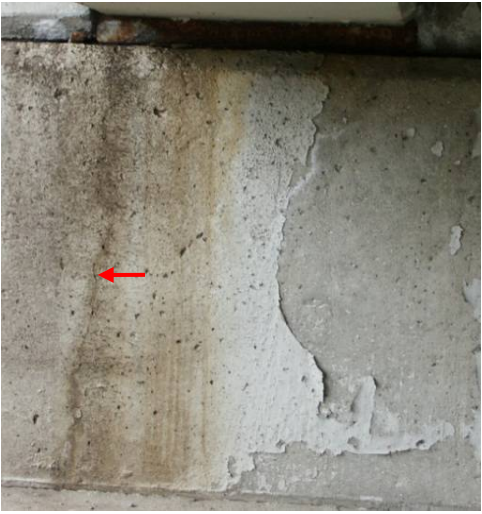
<p data-bbox="358 1297 691 1325">Vertical crack under bm 1W</p>

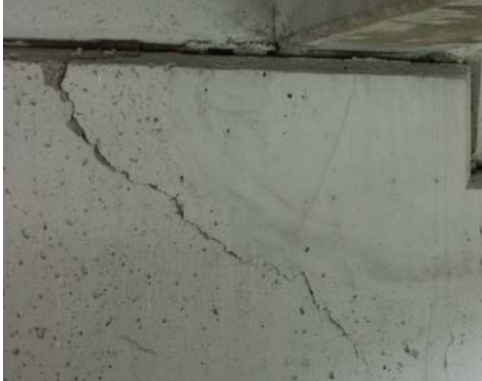
<p data-bbox="878 968 1364 1031">Abutment wall D-crack with incipient spall under beam 2W</p>

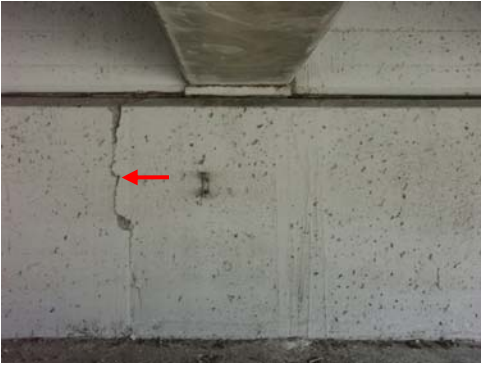
<p data-bbox="248 1717 802 1772">Delamination, cracks, incipient spall, and patch work under beam 7W</p>

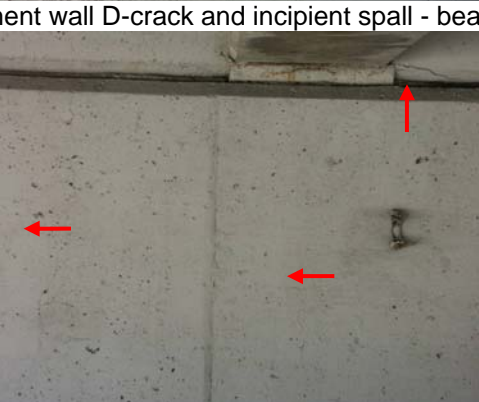
<p data-bbox="280 951 773 982">Horizontal and vertical cracks at beam 3W</p>

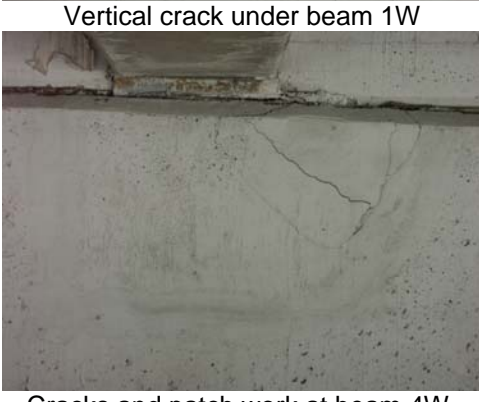
<p data-bbox="930 951 1357 1003">Cracks and patch work at beam 4W. Horizontal backwall crack</p>

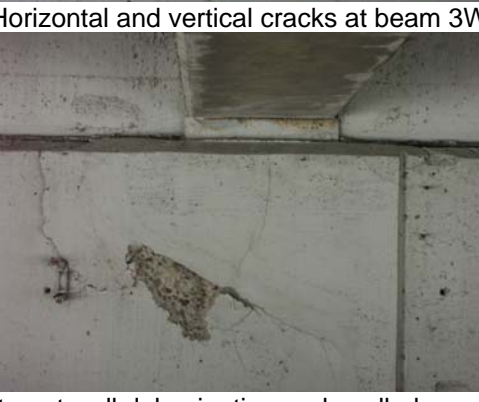
<p data-bbox="240 1350 821 1381">Abutment wall delamination and spall - beam 5W</p>

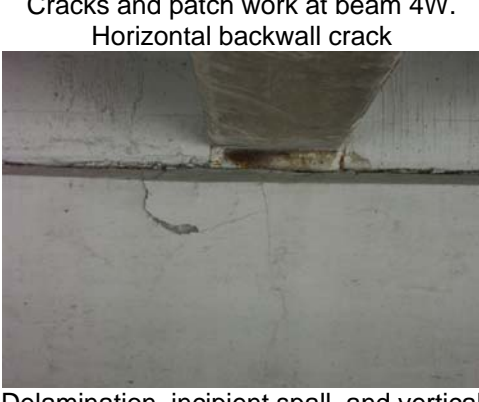
<p data-bbox="906 1350 1382 1402">Delamination, incipient spall, and vertical crack under beam 5W.</p>

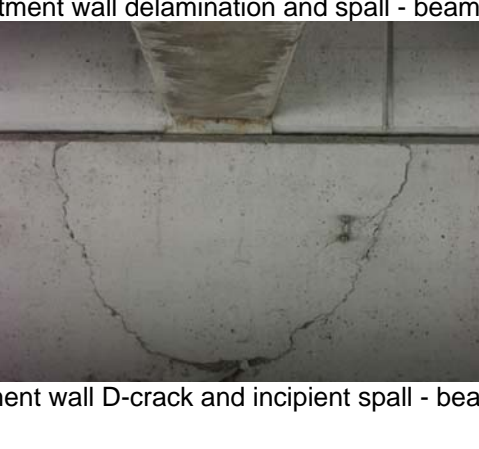
<p data-bbox="215 1728 841 1759">Abutment wall D-crack and incipient spall - beam 6W</p>

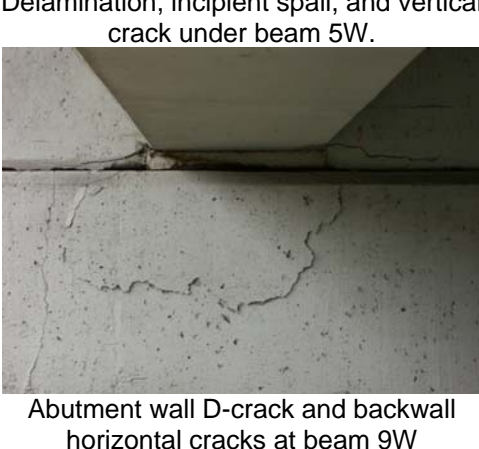
<p data-bbox="930 1728 1357 1801">Abutment wall D-crack and backwall horizontal cracks at beam 9W</p>

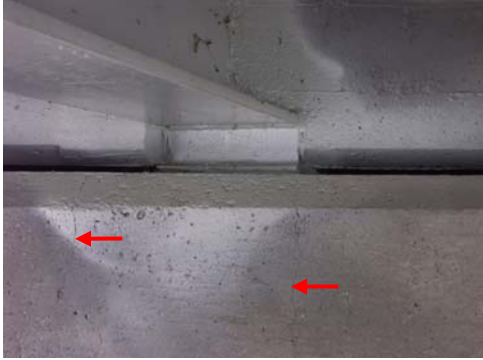
<p data-bbox="321 583 680 615">Vertical crack under beam 2W</p>

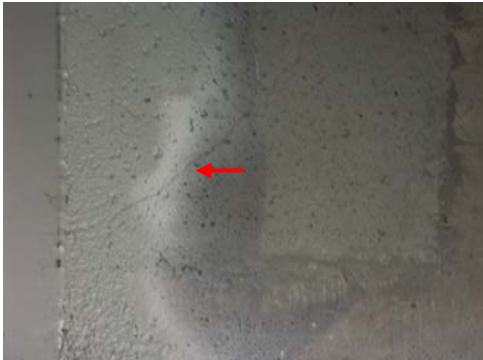
<p data-bbox="305 1360 696 1392">Backwall crack next to beam 5W</p>

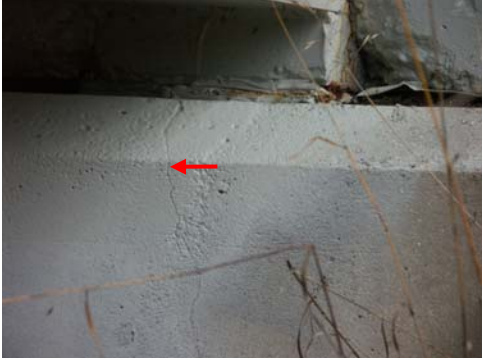
<p data-bbox="943 583 1302 615">Vertical crack under beam 1W</p>

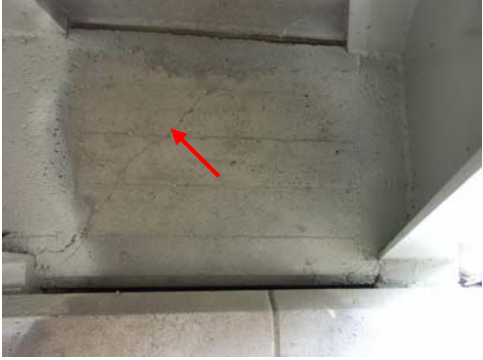
<p data-bbox="837 972 1408 1035">Diagonal backwall crack between beam 1W and 2W</p>

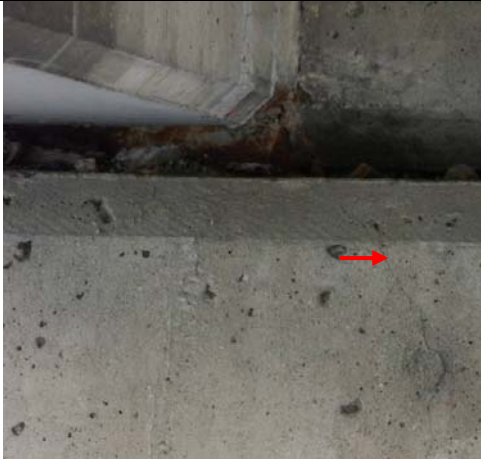
<p>Vertical crack under beam 1W</p>

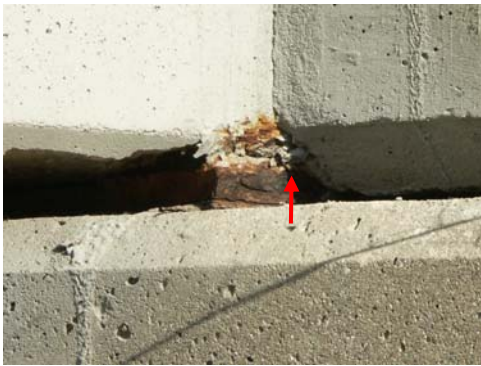
<p>Spall at bearing under beam 4W</p>

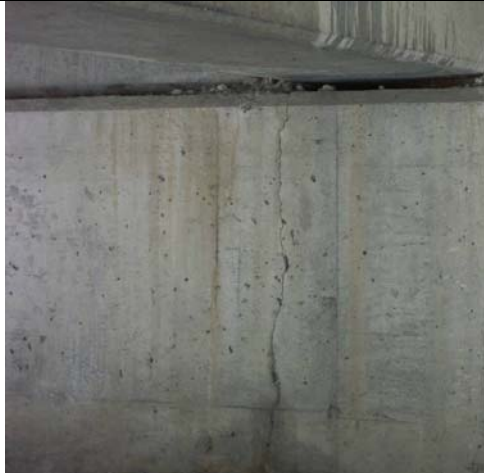
<p>Vertical crack under beam 2W</p>

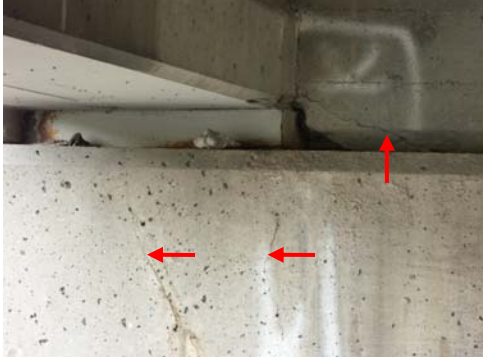
<p data-bbox="240 583 764 646">Vertical abutment wall cracking and backwall cracking near bearing of beam 1W</p>

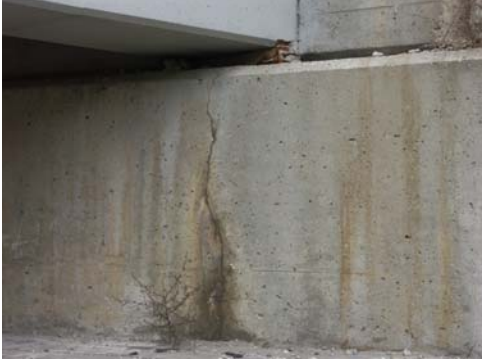
<p data-bbox="943 583 1302 615">Vertical crack under beam 1W</p>

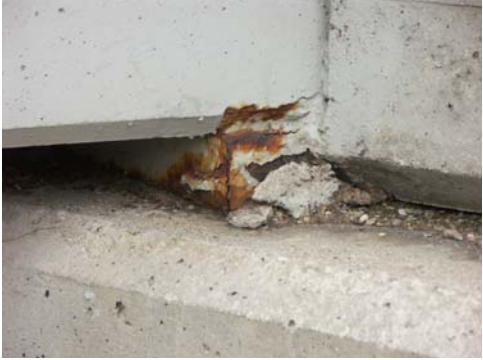
<p data-bbox="951 972 1294 1003">Spalling at beam bearing 1W</p>

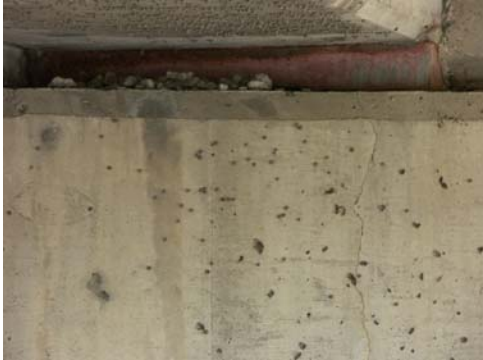
<p>Vertical abutment wall crack under beam 2W</p>

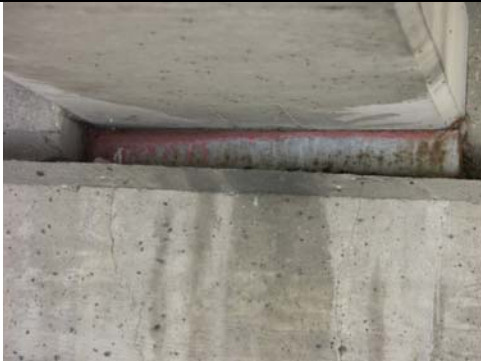
<p>Vertical cracks under beam 2W</p>
